Contract #: 04-0120F4Cty: SF/ALA Rte: 80 PM: 13.2/13.9File #: 69.28**WELDING INSPECTION REPORT****Resident Engineer:**Pursell, Gary**Address:** 333 Burma Road**City:** Oakland, CA 94607**Report No:** WIR-002874**Date Inspected:** 09-Jun-2008**Project Name:** SAS Superstructure**OSM Arrival Time:** 1800**Prime Contractor:** American Bridge/Fluor Enterprises, a JV**OSM Departure Time:** 730**Contractor:** Zhenhua Port Machinery Company, Ltd (ZPMC), Changxing Island **Location:** Shanghai, China**CWI Name:** An Qing Xiang**CWI Present:** Yes No**Inspected CWI report:** Yes No N/A**Rod Oven in Use:** Yes No N/A**Electrode to specification:** Yes No N/A**Weld Procedures Followed:** Yes No N/A**Qualified Welders:** Yes No N/A**Verified Joint Fit-up:** Yes No N/A**Approved Drawings:** Yes No N/A**Approved WPS:** Yes No N/A**Delayed / Cancelled:** Yes No N/A**Bridge No:** 34-0006**Component:** Tower**Summary of Items Observed:**

WELDING INSPECTION REPORT

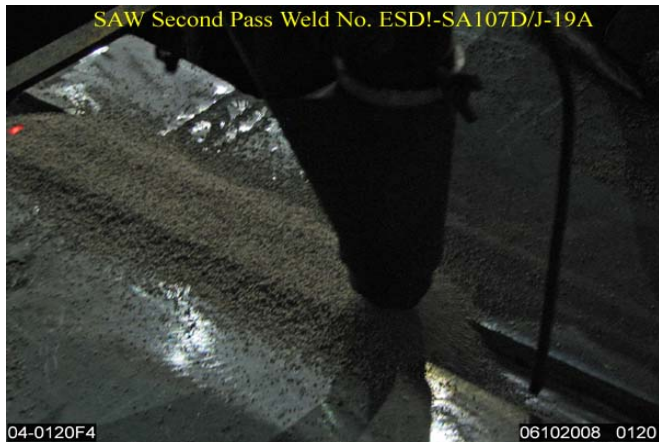
The Caltrans QA Inspector also randomly observed the machine Submerged Arc Welding (SAW) of the root pass and second pass on Weld Nos. ESD1-SA107F/J-21A and ESD1-SA107D/J-19A, Skin Plate Face "A" in the flat groove (1G) welding position. The welding operator for both welds was Cao Gui mei (I. D. No. 047304) and the Welding Procedure Specification (WPS) No. was WPS-B-T-2221-B-U3c-S-1. Certified Welding Inspector (CWI), An Qing Xiang (CWI No. 07120651), was present during the welding, as was ABF QA Inspector, Wang Cheng jun. The QA Inspector verified the qualifications of the welding operator, and that the electrode/flux classification, diameter of electrode, amperage, voltage, travel speed, and preheat/interpass temperatures were within the specified ranges on the WPS.

All above observations appeared to meet the requirements of the job specifications.
